National Register of Historic Places Registration Form

historic name Rochester Downtown Historic District

state Indiana code IN county Fulton code 049 zip code 46975

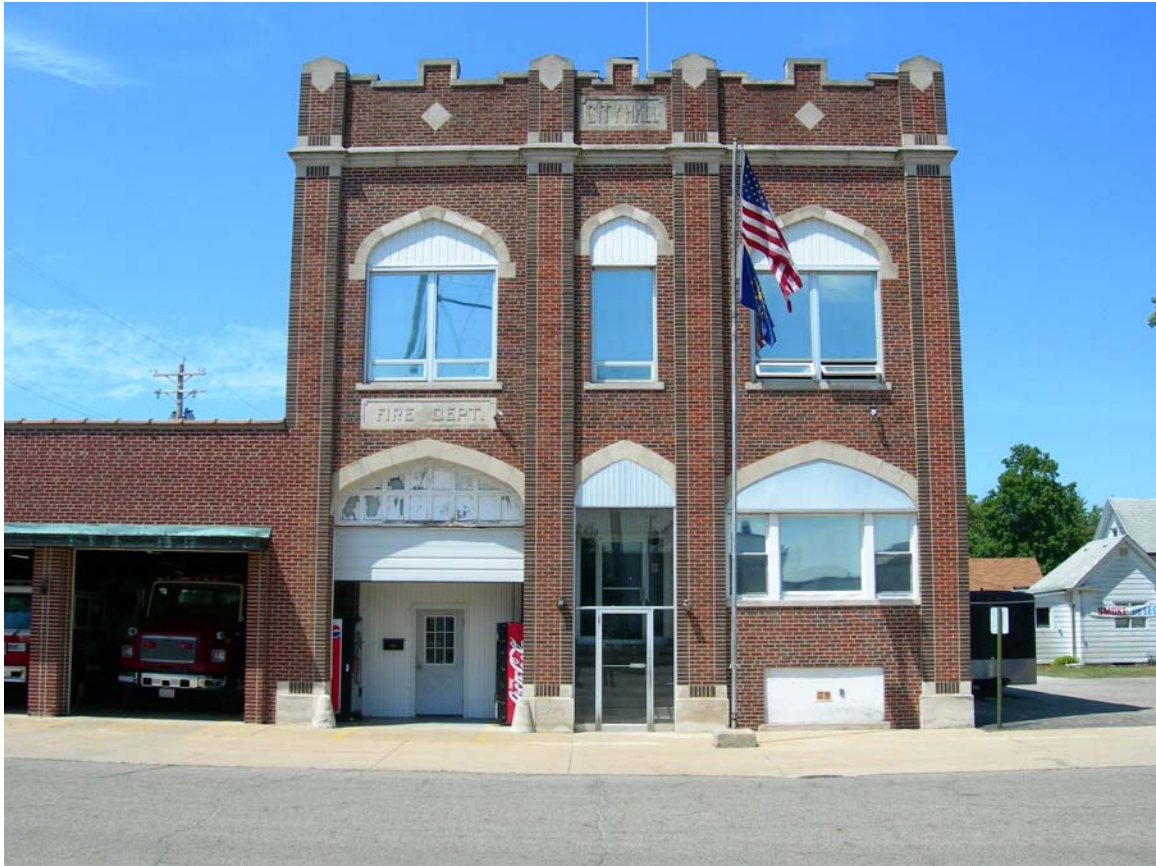
Rochester Downtown Historic District, Photograph #1

122 E. 7th Street, contributing: Fire Department/Rochester City Hall, c. 1915. Tudor Revival (photo 1) This two story brick building has a façade divided into three bays by brick pilasters set on limestone bases, extending to the parapet. The brick pilasters have a dark brick accent course laid vertically at each side, set on square limestone blocks with dark brick between the blocks. The limestone blocks terminate the pilaster at the cornice, then the detail continues again above the cornice in the parapet wall. Window and door openings have limestone pointed arches and limestone sills. The center bay is narrow and has a tall door opening with steps recessed in the opening. The opening has aluminum storefront door and glass infill with metal infill in the arched area. Originally the steps were open to the exterior and a wood exterior door was set at the main level. The left bay has a wide opening, formerly with a recessed door for fire equipment storage with conical limestone guards at the base of the opening. It is equal in height to the center doorway with a multi-paned transom infill in the arched portion of the opening. It is unclear if this is original to the building, however, it similar to the style of window composition in the other openings as seen in an old photograph of the building. Wood frame infill now exists, recessed in the opening with a single man door. Above the opening is an engraved limestone name block with "FIRE DEPT." inscribed. The right bay has a low window opening at sidewalk level, once consisting of a group of three nine-lite window sashes, but it has been filled in with plywood. Another window opening in the right bay is the same width and height as the opening in the left bay and has a three-wood window combination with 1/1 windows flanking a larger middle fixed window. The windows rest on a limestone sill and the arched area has been filled in with metal. This opening once had a larger middle fixed window with flanking multi-paned windows and multi-paned transom similar to that over the fire equipment bay opening.

Second floor openings are slightly narrower than the first floor bay openings, but match with pointed limestone arches and have limestone sills. These window openings have replacement metal windows with awning style window units at the sill level and fixed units above. The arched area has framing/metal infill. The outside openings once had a composition of three windows with large multi-paned transom over the entire composition. A larger 6/1 double-hung window was flanked by narrow fixed 10 lite sashes. The center second story opening is narrower, and once had two joined narrow 10-lite sashes with a multi-paned transom above. A limestone cornice extends above the second floor openings, projecting with the pilasters that continue through to the parapet. The parapet is mostly brick with limestone coping following a crenellated pattern. Limestone diamonds appear over the left and right bays and a limestone name block with "CITY HALL" inscribed on it is over the center bay. Side elevations of the building have combinations of round arched top and flat topped window openings and a clay tile parapet cap.

A ca. 1950 single story brick addition for more fire equipment was made to the left of the original building. The addition was constructed in brick closely matching the original building and has three equal garage bay openings on its façade with a copper rain hood across the entire façade, just above the openings. A brick parapet exists with a clay tile parapet cap.

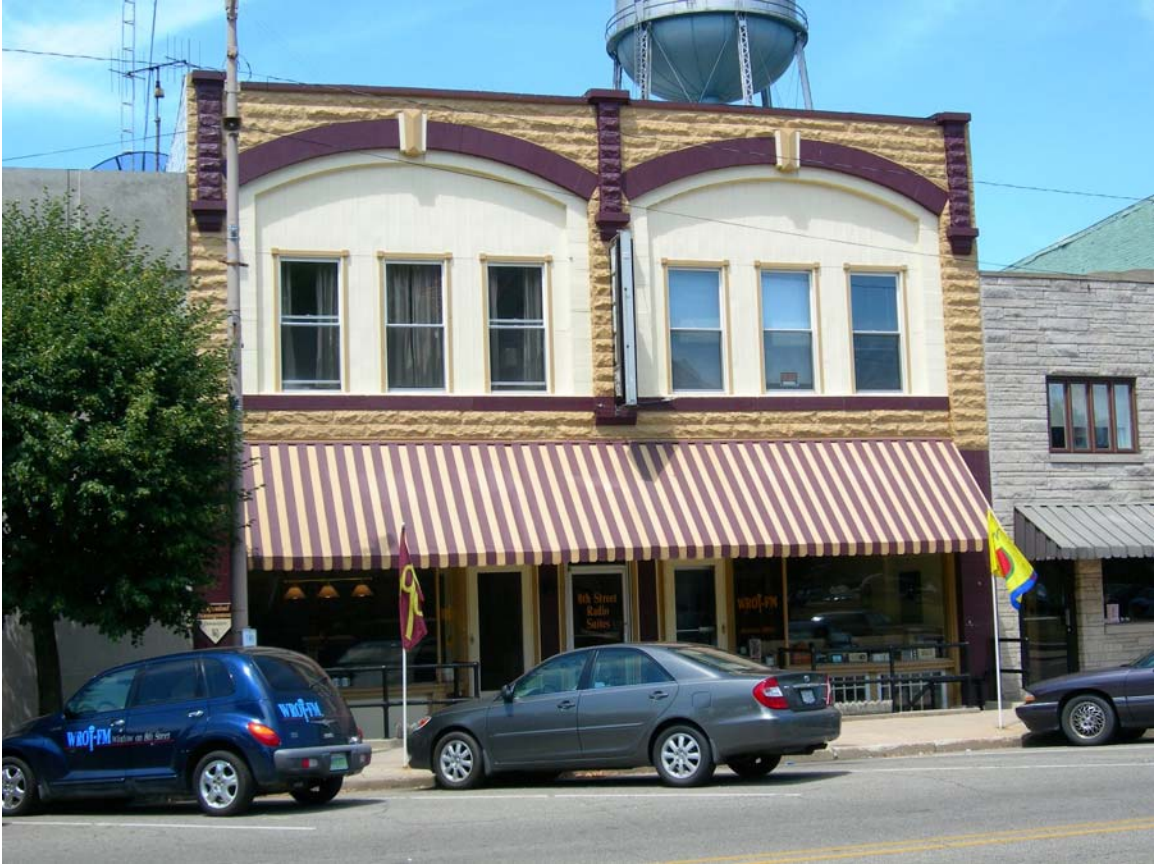
Rochester Downtown Historic District, Photograph #5

110-112 E. 8th Street, contributing: Holman/Stephenson/Shields Building, 1905. Romanesque Revival (photo 5). The building is a two-story, mostly rusticated limestone block structure with a symmetrically organized façade with two storefront bays flanking a center stairway door on the ground level. Two below grade shops also exist and are accessed by steps to the sidewalk above. These openings are protected by steel handrails and are toward the outside walls of the building, on the front façade. The lower level storefronts have steps on each side that return under an overhead walk from the main level above in the center of the building. Each has its own entry door. The lower level right bay storefront has a fully intact wood storefront with upper wood window sash with multiple-divided lites. The main level storefront bays have large display windows toward the outside walls, with angled returns to the recessed entry doors. Smooth limestone pilasters are on the outside walls of the front façade, but become rusticated once above the storefront level. Storefront material appears to be original wood and limestone construction. Large display windows have small square art glass blocks for transoms. Doors appear to be replacements with the transom area in-filled with plywood, except for the center stairway door's transom which is a wood window.

The second floor has two wide arched openings, with smooth, segmented limestone arches and smooth limestone sills. A limestone keystone projects at the top of each arch. A center rusticated pilaster separates the two openings. At roughly the resting point of the arch bases, another rusticated pilaster projects from those defining the building ends and center and projects just above the parapet capstone. The parapet has a smooth face stone coping that was added after the upper decorative parapet wall was removed. Originally the front façade was taller with a beaux-arts style arched parapet continuing above each of the large arched openings on the second floor. It appears this removal was completed in the mid-20th century. The openings on the second floor have aluminum infill with three non-historic windows in each opening.

The Romanesque Revival styled building at 110-112 E. 8th Street (photo 5) and the Neo-Classically designed Dillon Building (now Bailey's-photo 17, left) at 712-714 Main Street are nearly identical in the storefront layout, detail and large arched openings on the second story façade, giving some indications they may have been constructed by the same designer/builder. Both buildings, particularly the Dillon Building, have well-preserved storefronts with lower level architectural elements still visible and in use.

114 E. 8th Street, non-contributing: Commercial Building, c. 1955 (photo 5, right)
Two story, single storefront building with limestone ashlar-stacked block finish on front façade. Storefront has single door and single window display opening starting at approximately four feet from sidewalk, and extending across most of the façade. Door and windows are aluminum storefront frames and glass. A much older limestone base appears at grade, below the ashlar veneer, but no other evidence exists to earlier construction. Second floor has two symmetrically placed masonry openings with smooth limestone sills. Windows are four-ganged casement units. A concrete parapet cap terminates the facade with a series of low curved features in the center.

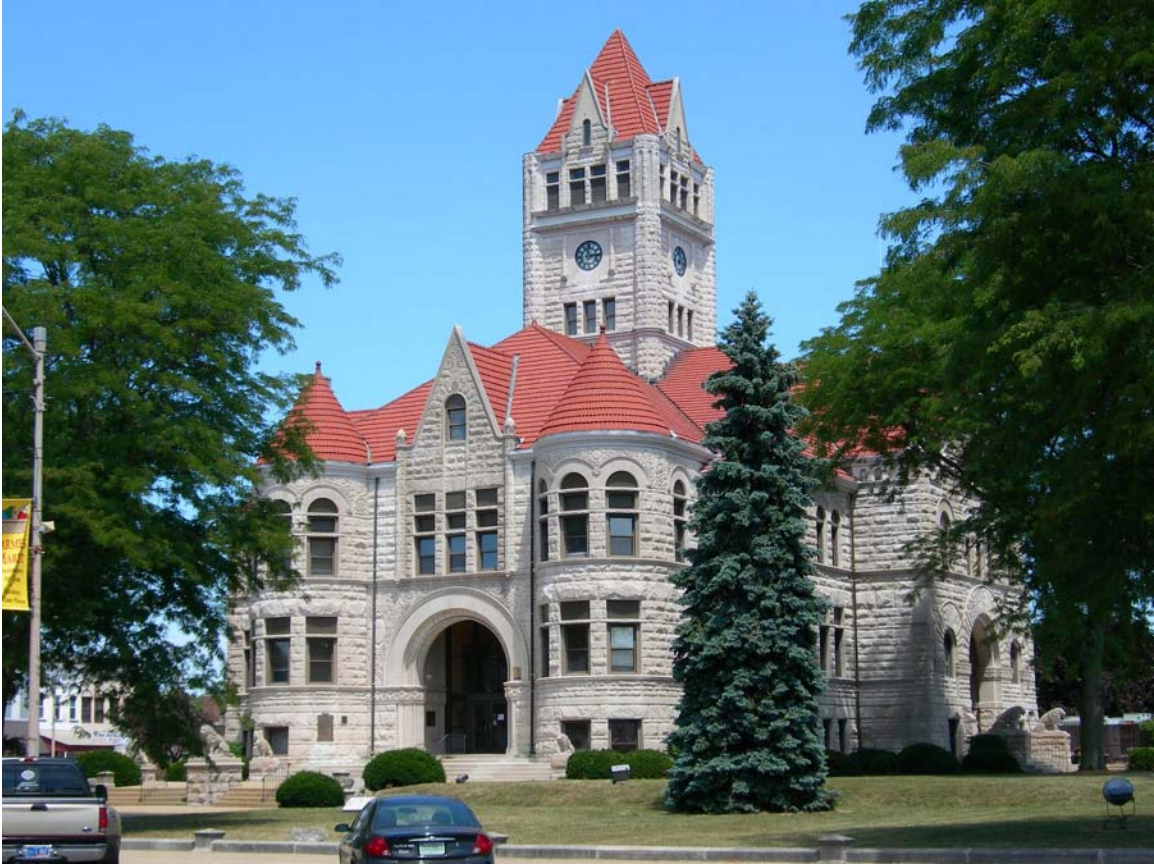
Rochester Downtown Historic District, Photograph #9

125 E. 9th Street, contributing: Fulton County Courthouse, 1896. Richardsonian Romanesque
Architect: A.W. Rush & Son; Builder: J.E. Gibson (photo 9, west/Main St. façade)
Courthouse square listed on the National Register of Historic Places.

the original early frame structures. The most substantial contribution to the streetscape was the construction of the current Fulton County Courthouse in 1895-96 (photo 9). The style of the building gives a sense of permanence and stability with its sheer mass and stone materials used in construction. Its design and construction appears to have influenced other building appearances and location around and near the courthouse square. On the courthouse square are located four monuments related to the history of Fulton County and/or military service. The courthouse was restored in celebration of its centennial and rededicated in 1995. The courthouse square, markers and building have been previously listed on the National Register of Historic Places.

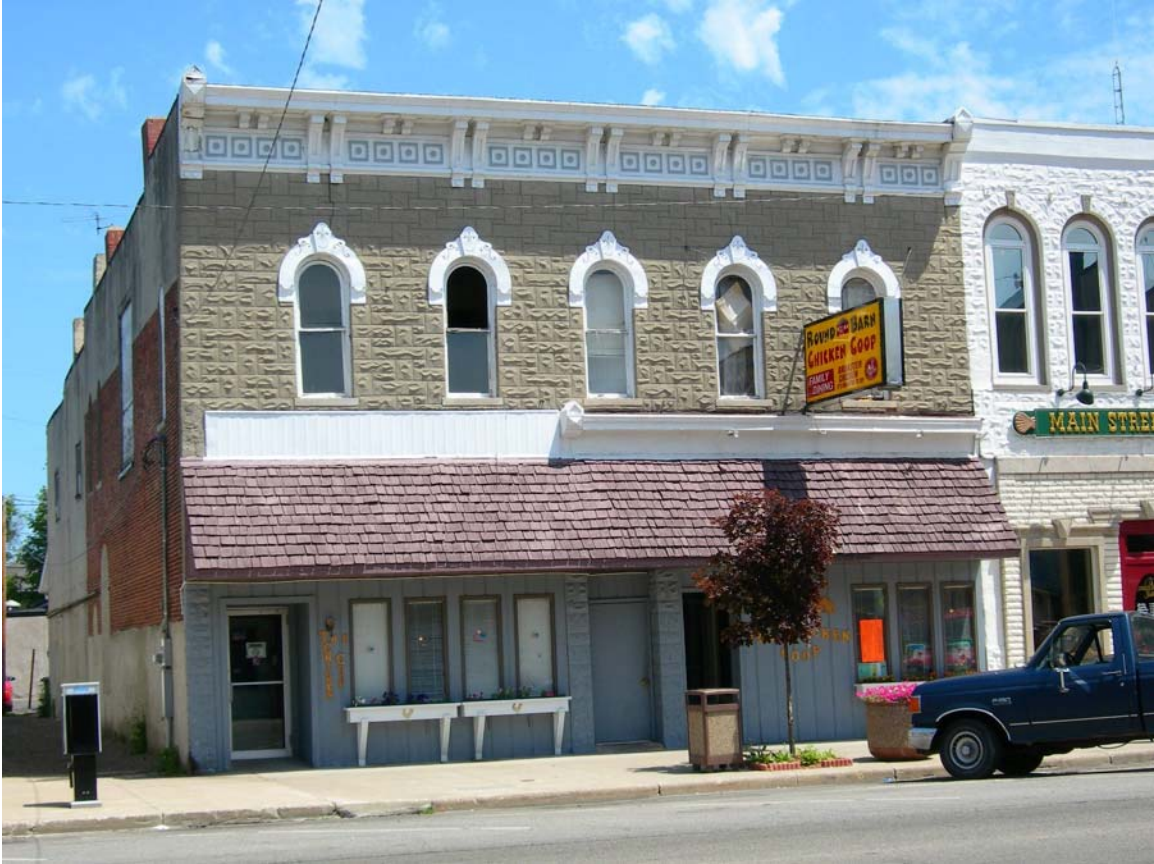
Rochester Downtown Historic District, Photograph #33

717-719 Main Street, contributing: Noftsgers/Robbins Building, c. 1890. Italianate (photo 33)

721 Main Street, contributing: Commercial Building, c. 1890. Italianate (photo 33, far right)
Two story masonry building with single storefront bay. The storefront bay has recent modifications: brick, cast stone, glazing, and a center entry door. Pilasters are located on each side of the storefront bay; the left pilaster appears to be stone and cement faux stone veneer. The right pilaster is cement faux stone veneer. The second story front façade has four masonry window openings joined together with a single faux stone course. The openings have smooth-face limestone sills and segmented faux stone arches with a limestone keystone. Windows are 1/1 clad windows with a clad half-circle transom. A metal fascia extends across the face of the front façade where the cornice was likely located. The parapet is capped with cement coping stones.
